The contribution of diagnostics in architectural survey; case study of combined thermography application.

Gerardo Maria CENNAMO

4. Case study: the bell tower of Sagittarius and the grange of Ventrile

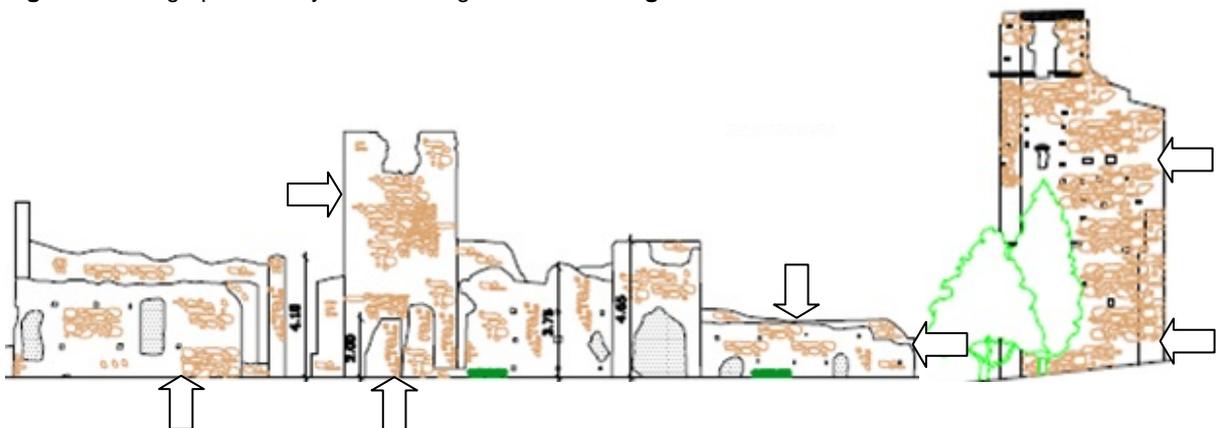
Fig. 9: Survey points on the Grangia and on the north tower

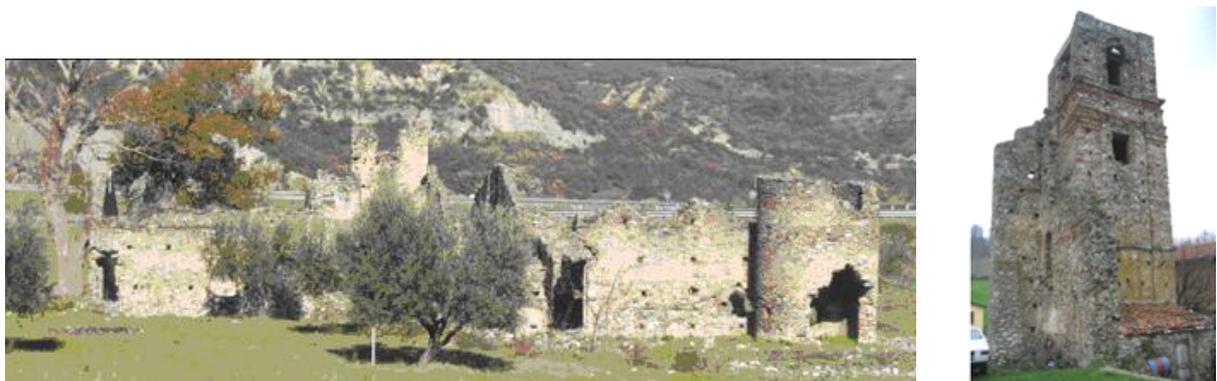
Fig. 10: Survey points on the photographic image
